Blowing Sand *in the* **Arabian Gulf**

By LCdr. Mike Saling

LCdr. Saling was the safety officer on USS *Iwo Jima* (LHD-7).

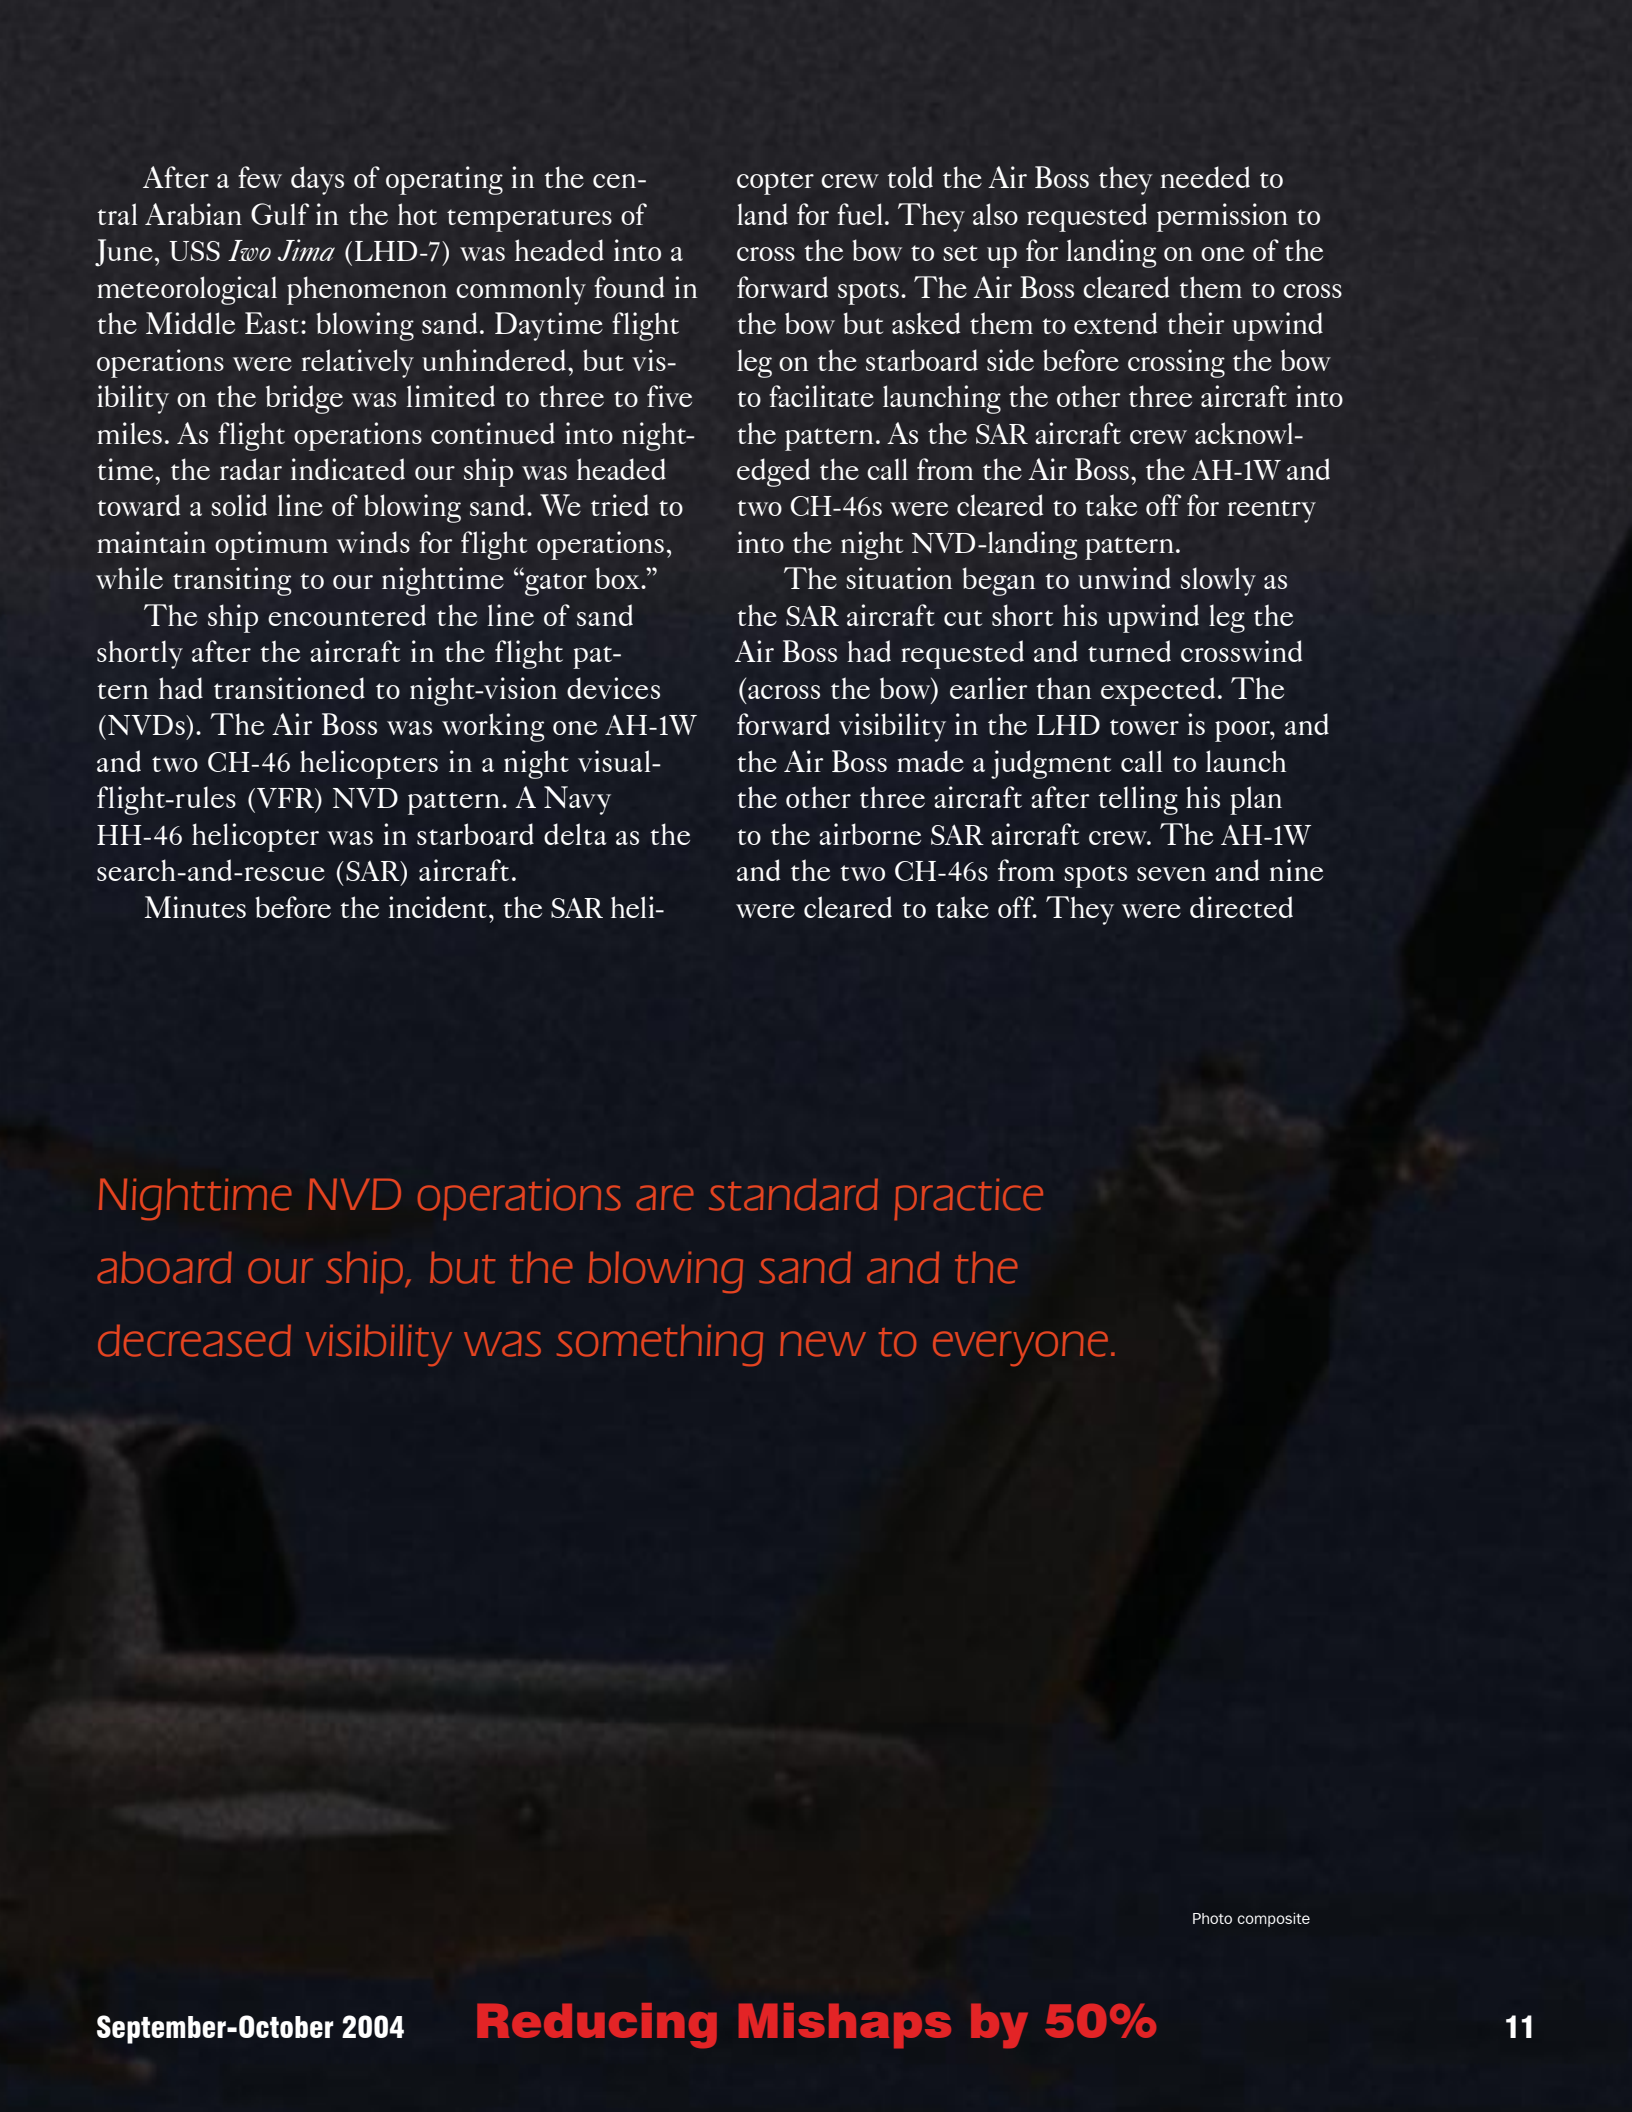
Photo composite

Nighttime NVD operations are standard practice aboard our ship, but the blowing sand and the decreased visibility was something new to everyone.
